CH-37

U. S. ARMY BOARD FOR AVIATION ACCIDENT RESEARCH • FORT RUCKER, ALABAMA

CH-37 ACCIDENT SUMMARY

1 July 1957 through 30 November 1966

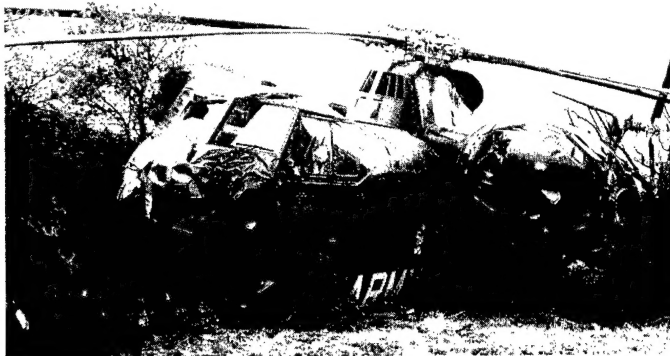
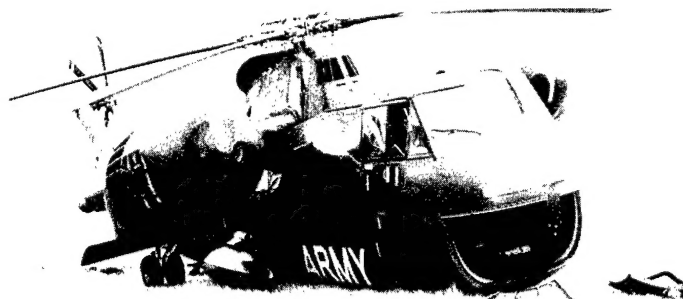
04603

04603—Helicopter lost altitude abruptly, following maximum performance takeoff, and settled into trees. Major damage to main rotor blades, tail rotor blades, landing gear, clamshell doors, engine and nacelles and fuselage. CAUSE: Shifting, gusty wind and downdraft, which the pilot did not anticipate prior to takeoff.

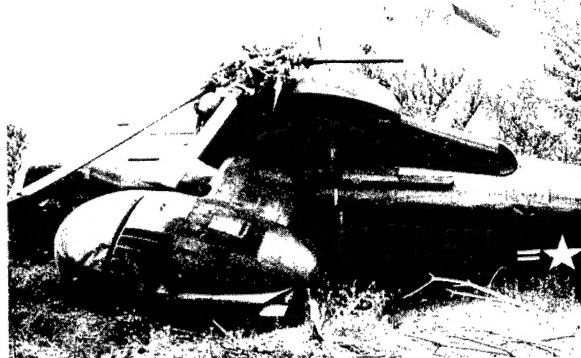
04318

04318—Right main gear hit soft spot in sod, digging in approximately one foot. Aircraft moved forward and came to rest on right auxiliary tank and right bottom side of fuselage. CAUSE: Landing gear down lock pin sheared during running landing due to soft spot.

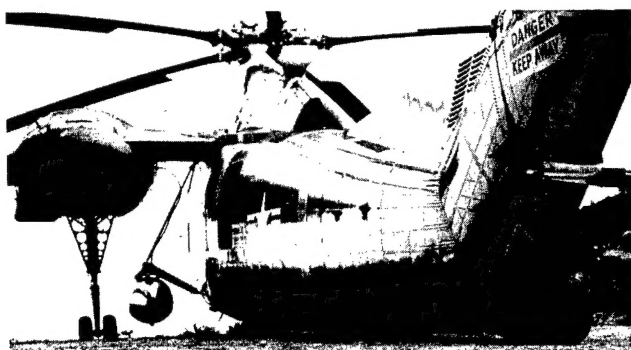
A117

A117—After takeoff, the No. 1 engine began to lose power. The helicopter failed to develop sufficient airspeed and altitude to clear wires across the flight path. Pilot attempted to abort takeoff and land. Helicopter settled through the wires and struck a curb, causing major damage to the tail wheel and pylon section. CAUSES: Engines failed to develop sufficient power for takeoff due to prolonged operation at ground idle which resulted in fouled plugs. Pilot selected takeoff flight path obstructed by wires and parked automobiles.

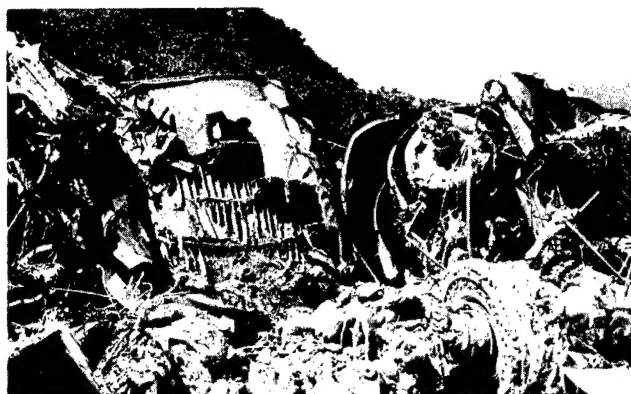
06742

06742—Helicopter flew into downdraft 15 feet above and 25 feet short of the desired touchdown spot during approach to mountain helipad. The pilot applied power and stopped the sink rate, but the tail wheel strut hit the edge of the concrete helipad. The helicopter continued forward and the tail wheel strut assembly was pulled loose from its attaching point. CAUSE: Failure to evaluate wind in the vicinity of the helipad.

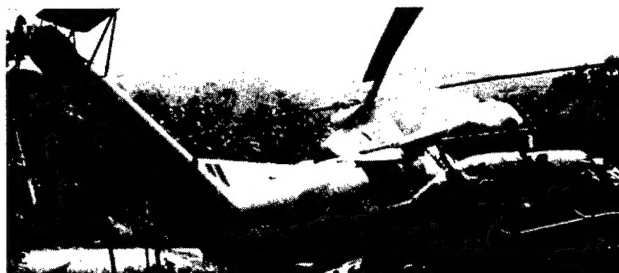
A284

A284—Helicopter approached a mountain helipad (altitude 3,800 feet) with a sling load of three telephone poles. Approximately 60 feet short of the helipad, a loss of lift occurred and the sling load was dropped. The pilot attempted to fly over the crest of the mountain and the helicopter struck a rocky ledge on the tail pylon, at a point approximately four feet forward of the tail wheel. As the

helicopter continued down the north slope of the mountain, the tail pylon separated from the fuselage and control was lost. The helicopter crashed and the auxiliary fuel tanks ruptured. The aircraft burned and five occupants were killed. CAUSE: Loss of lift during final stages of the approach, coupled with high density altitude and near maximum gross weight condition.
